Forest View Acres Water District

Operations Report – September 2022

**Inspection Report for
Forest View Acres WD
Monument, CO**

250KG Steel On-Grade Tank

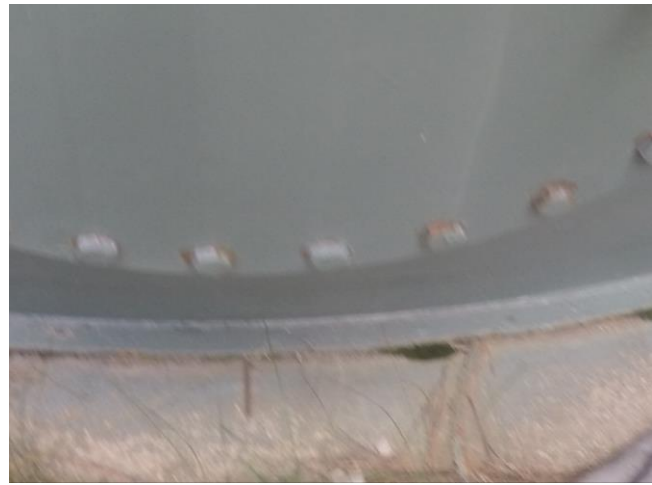
Foundation Condition

1. There was good access to the tank.
2. The foundation was found in good condition with minor voids and hairline racking noted.
3. The wall was found in good condition with minor de-lamination, sags & runs in the coating and 0.01% uniform surface corrosion noted.

Summary: The foundation was found in good condition with minor voids and hairline racking noted.

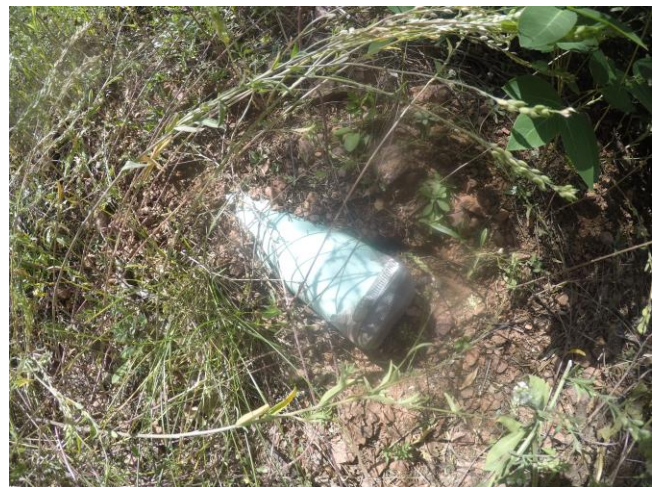
Overflow Structure Condition

Summary: The overflow was found in good condition with minor de-lamination, moderate sags & runs in the coating and 0.01% uniform surface corrosion noted.

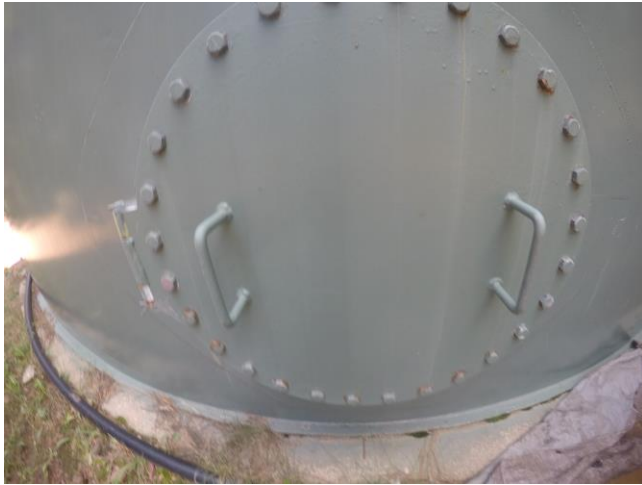
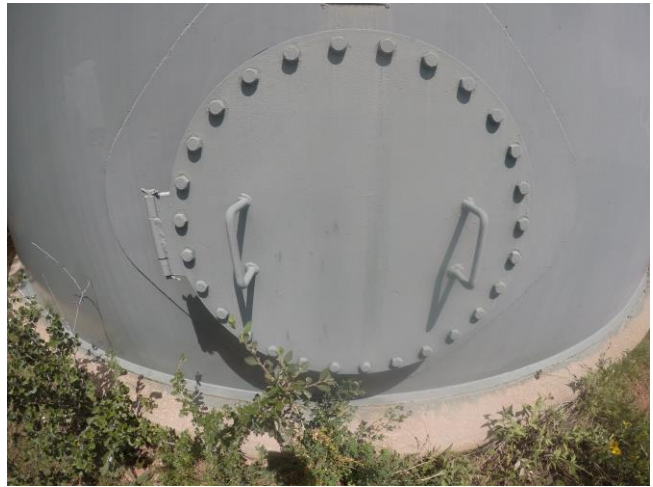
Manway Condition

Summary: The manways were found secure and in good condition with minor de-lamination, oxidation, sags & runs in the coating and 0.01% uniform surface corrosion noted

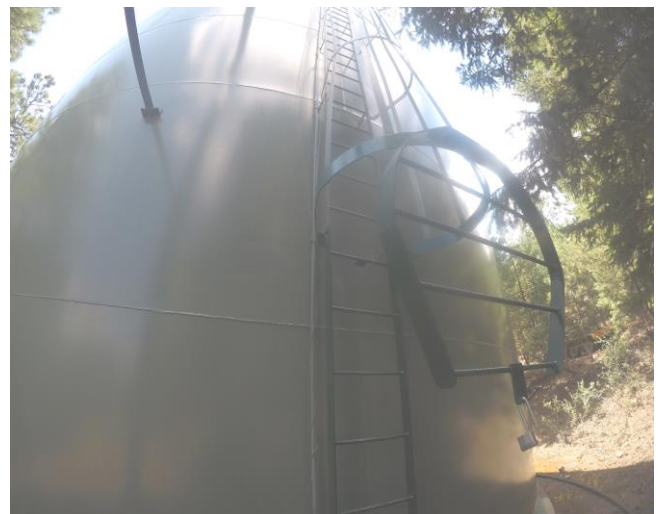
Access Ladder Condition

Summary: The ladder was found secure, OSHA approved and in good condition with minor de-lamination, sags & runs in the coating and 0.01% uniform surface corrosion noted.

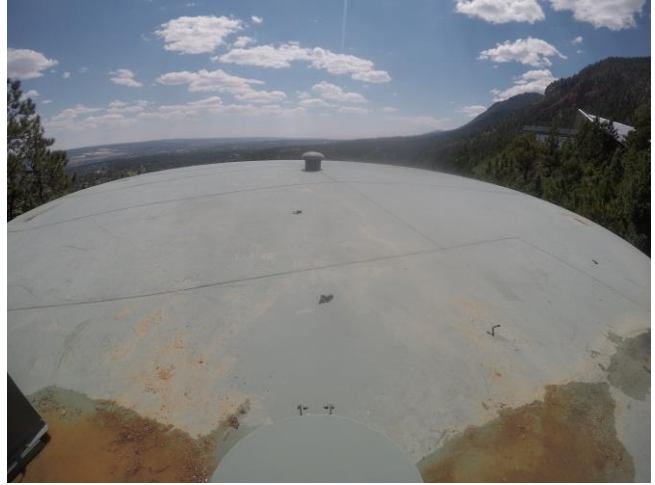
Roof Condition

Summary: The roof was found in good condition with minor de-lamination, sags & runs in the coating and minor to moderate chalking noted.

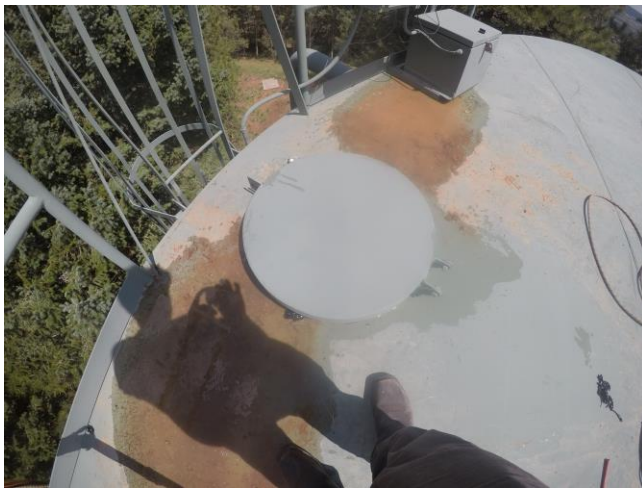
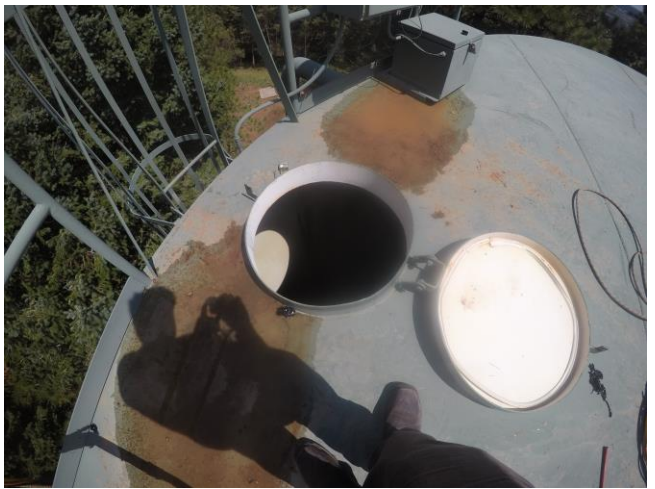
Access Hatch Condition

Summary: The hatch was found locked with a gasket in place and in good condition.

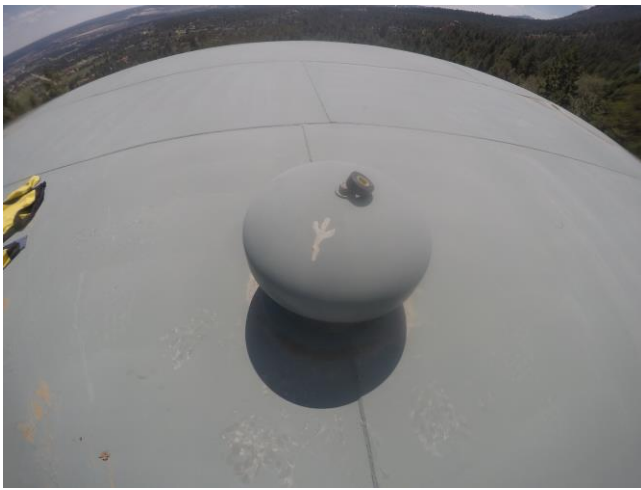
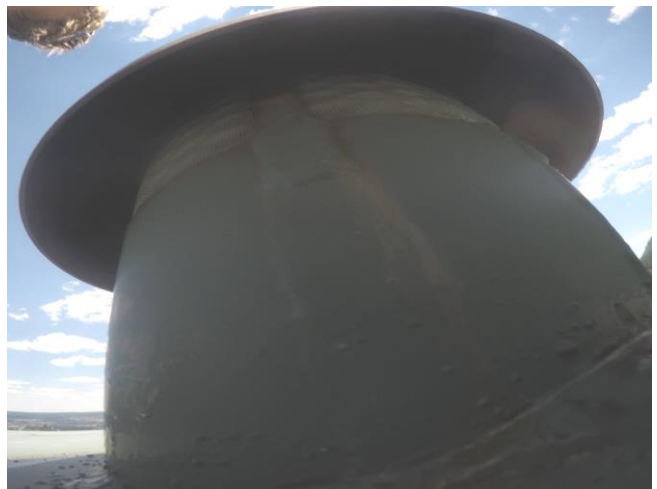
Vent Condition

Summary: The vent was found in good condition with minor oxidation, sags & runs in the coating, chalking and 0.01% uniform surface corrosion noted.

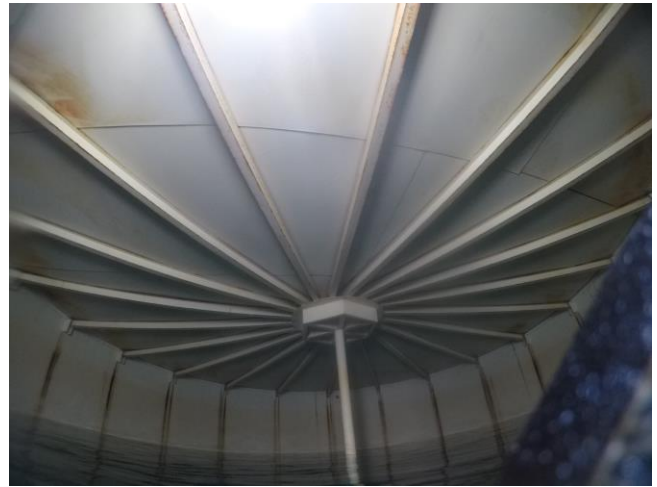
Roof Condition

Summary: The interior roof was found in good condition with minor de-lamination, corrosive staining and 0.01% uniform surface corrosion & intergranular corrosion noted.

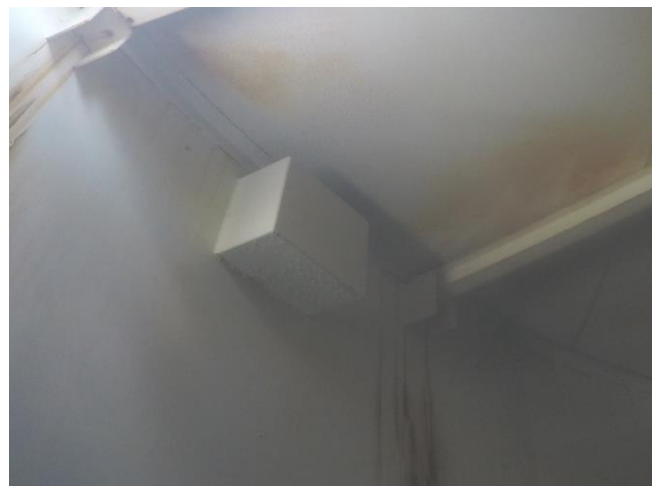
Overflow Condition

Summary: The overflow was found in good condition.

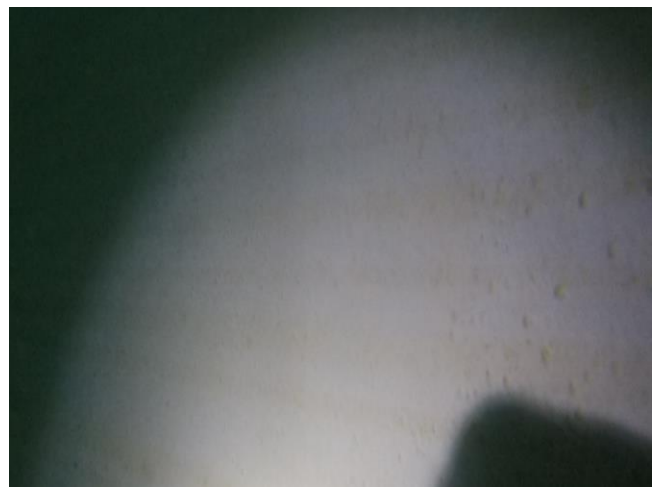
Wall Panel Condition

Summary: The interior wall was found in good condition with minor sags & runs in the coating, micro & macro blistering and minor to moderate sediment staining noted.

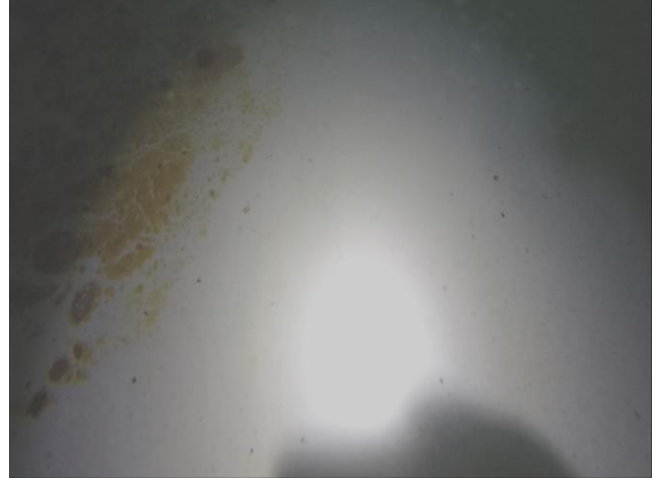
Floor Condition

Summary: The floor was found in good condition with minor de-lamination, minor to moderate corrosive & sediment staining and 0.01% rust noduling noted.

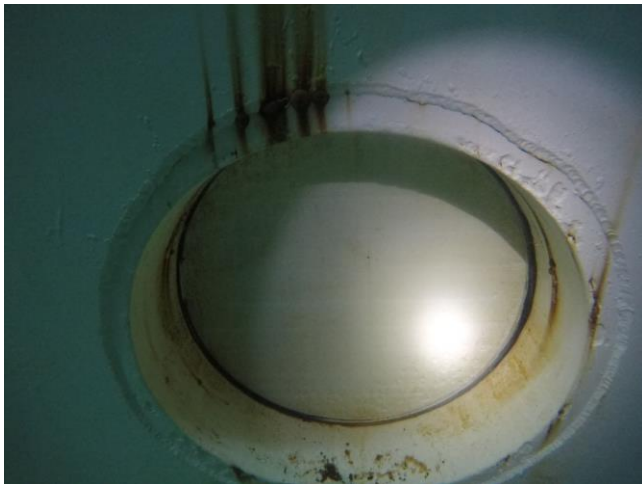
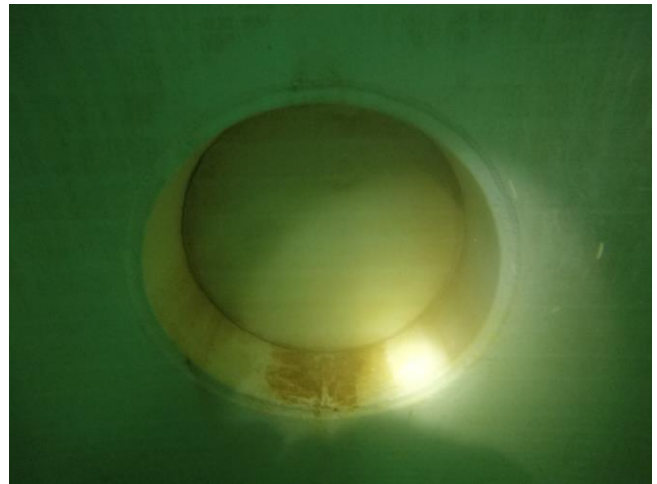
Manway Condition

Summary: The manways were found in good condition with minor de-lamination, sags & runs in the coating, heavy sediment staining, 0.01% intergranular corrosion and 0.1% rust noduling noted.

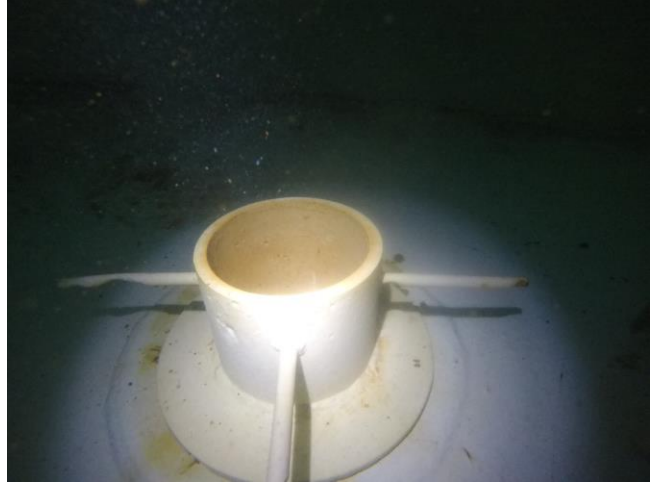
Inlet and Outlet Condition

Summary: The common inlet/outlet was found in good condition with minor micro & macro blistering, minor to moderate sediment staining, moderate sags & runs in the coating and 0.01% uniform surface corrosion noted.

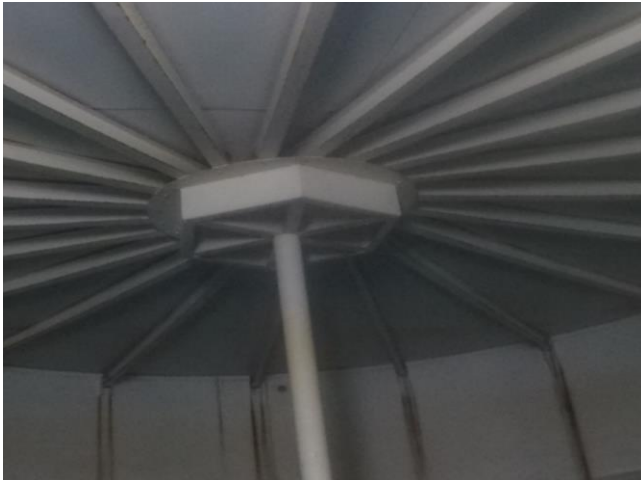
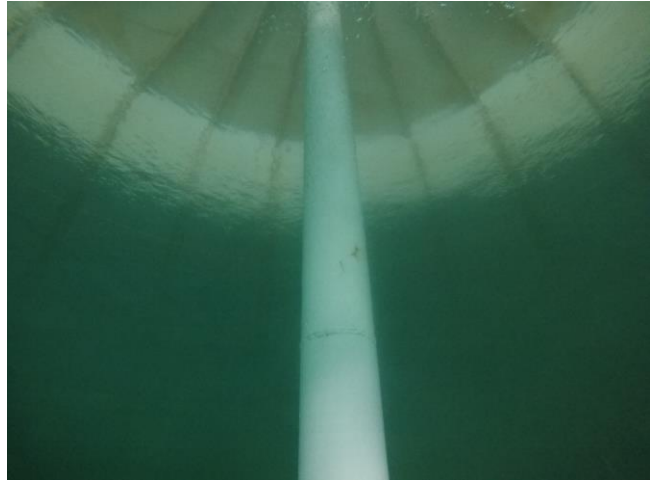
Support Column Condition

Summary: The support column was found secure and in good condition with minor sags & runs in the coating, minor to moderate corrosive & sediment staining and 0.1% rust noduling noted
