Forest View Acres Water District (FVAWD) Capital Improvement Plan

May 20, 2018 - draft

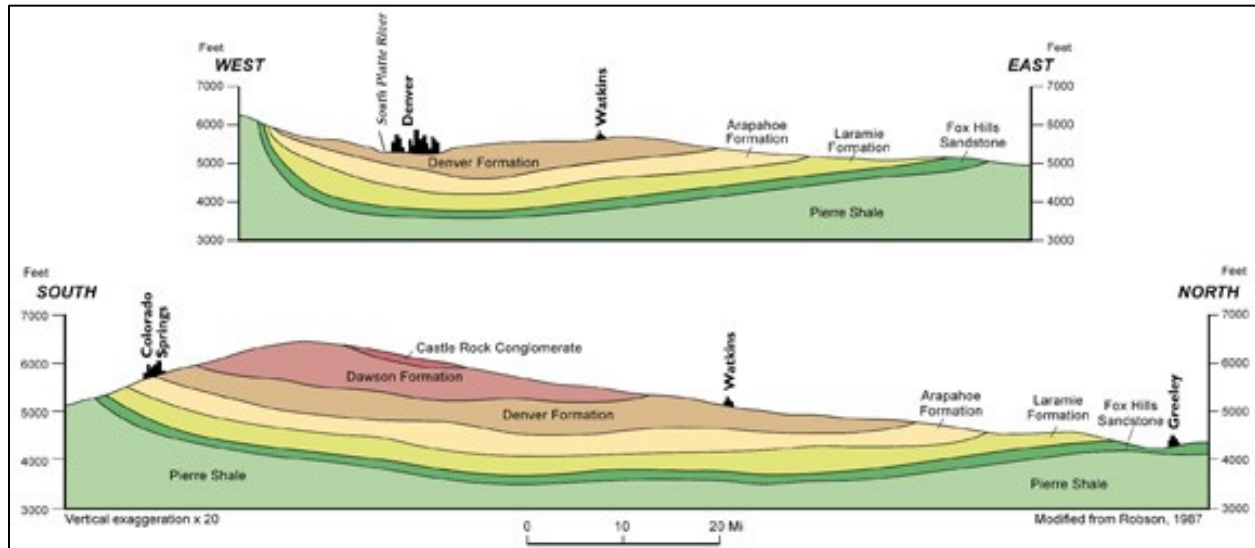
Figure 3. Denver Basin

Denver Basin. The Denver Basin is structural, sedimentary rock basin underlying a 6,700 square mile area that includes Denver and Colorado Springs. It is an important nonrenewable source of ground water for much of the Front Range. FVAWD is located near the southwestern edge of the Denver Basin. As illustrated in Figure 3, the Denver Basin is comprised of layered geologic formations. Within this, four aquifers are statutory defined: Dawson, Denver, Arapahoe, and Laramie-Fox Hills. FVAWD has water rights to all four aquifers. Wells in these aquifers are governed by CRS (Colorado Revised Statutes) 37-90-137, CRS 37-92-602, and the Denver Basin Rules.

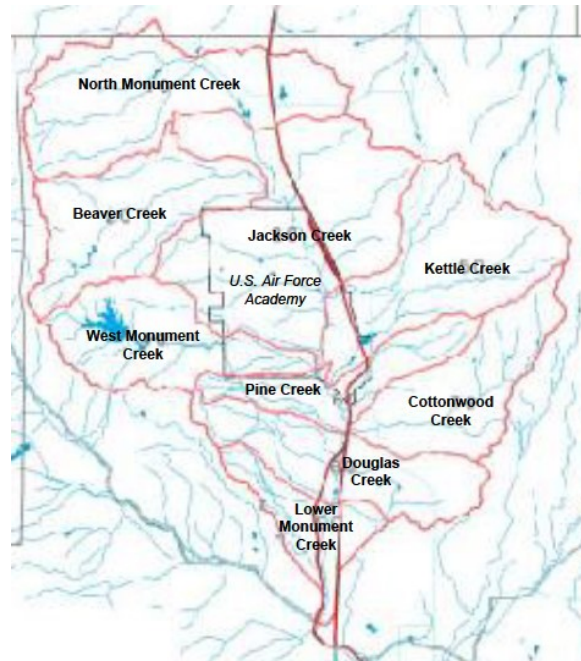
Figure 4. Monument Creek Watershed

North Monument Creek Watershed. The Monument Creek Watershed is located in northwestern El Paso County and encompasses approximately 151,300 acres. The Monument Creek Watershed is part of the Fountain Creek Watershed and of the larger Arkansas River drainage. In simple terms, a watershed is the area of land uphill from a point in a stream that forms a collection basin (almost like a funnel) where all the water on that land drains off to the same place. As can be seen in Figure 4 in the Air Force Academy is roughly in the center of the Monument Creek Watershed. Numerous faults run through the Monument Creek watershed.

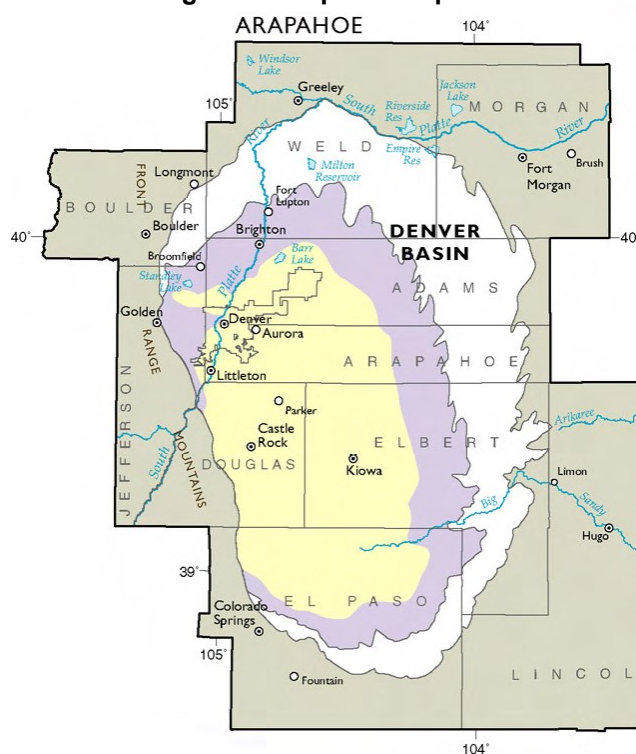
Figure 5. Arapahoe Aquifer

Denver Basin. Figure 5 shows the underground location of the Arapahoe Aquifer (aquifer shown in purple).

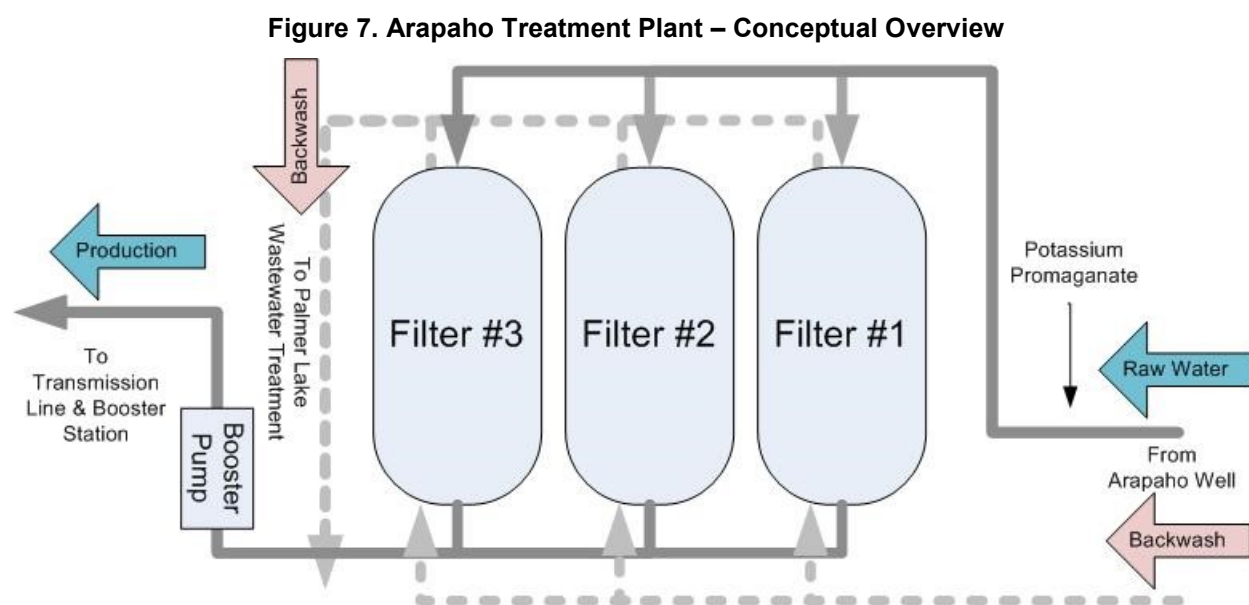
Figure 7 shows a simplified drawing of the ATP. This drawing is conceptual only and omits important details of the plant's control points, various valve locations (i.e., for check valves, pressure relief valves, or control valves), pressure meters, compressor, mixers, recorders, etc.

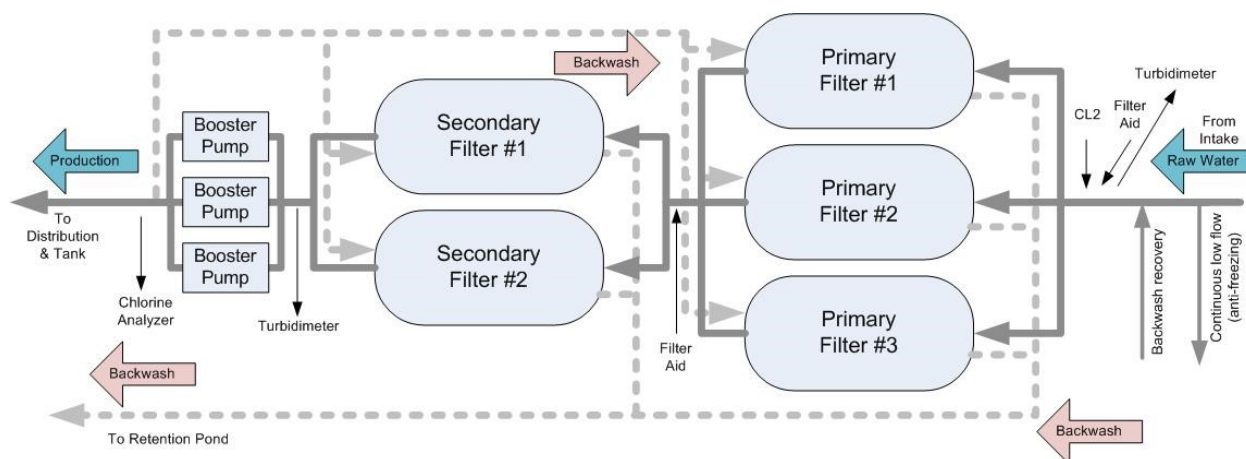
Figure 8. Surface Water Treatment Plant – Conceptual Overview

Figure 8 shows a simplified drawing of the SWTP. As with the drawing for the ATP, this drawing is conceptual only and omits important details of the plant's operational components.
